NASA TECHNICAL NOTE

NASA TN D-563

INVESTIGATION OF S-IV ALL SYSTEMS VEHICLE EXPLOSION

Compiled and edited by J. B. Gayle

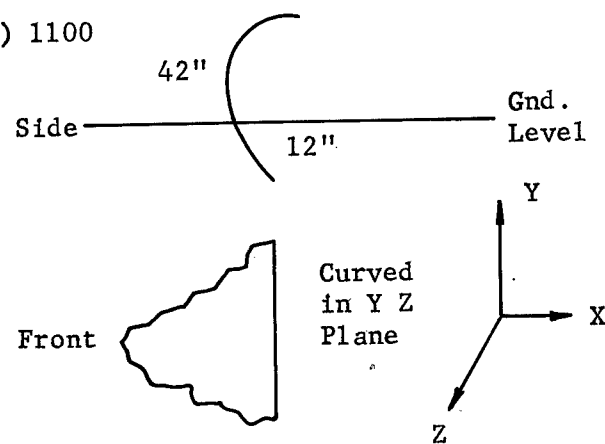
Item No.	Identification	Weight Lbs.	Distance Ft.	Size In.	Shape
43.	6-67 13- -A LH ₂ Tank Structure	20(Est)	1100	42"

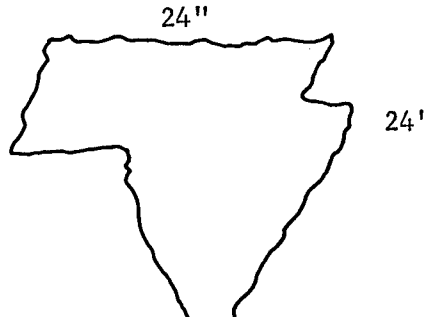
<p>Side</p> <p>Gnd. Level</p> <p>12"</p> <p>42"</p> <p>Front</p> <p>Curved in Y Z Plane</p> <p>Y</p> <p>X</p> <p>Z</p>
44.	C-10 Area 6-59 Common Bulkhead	5(Est)	800	24"

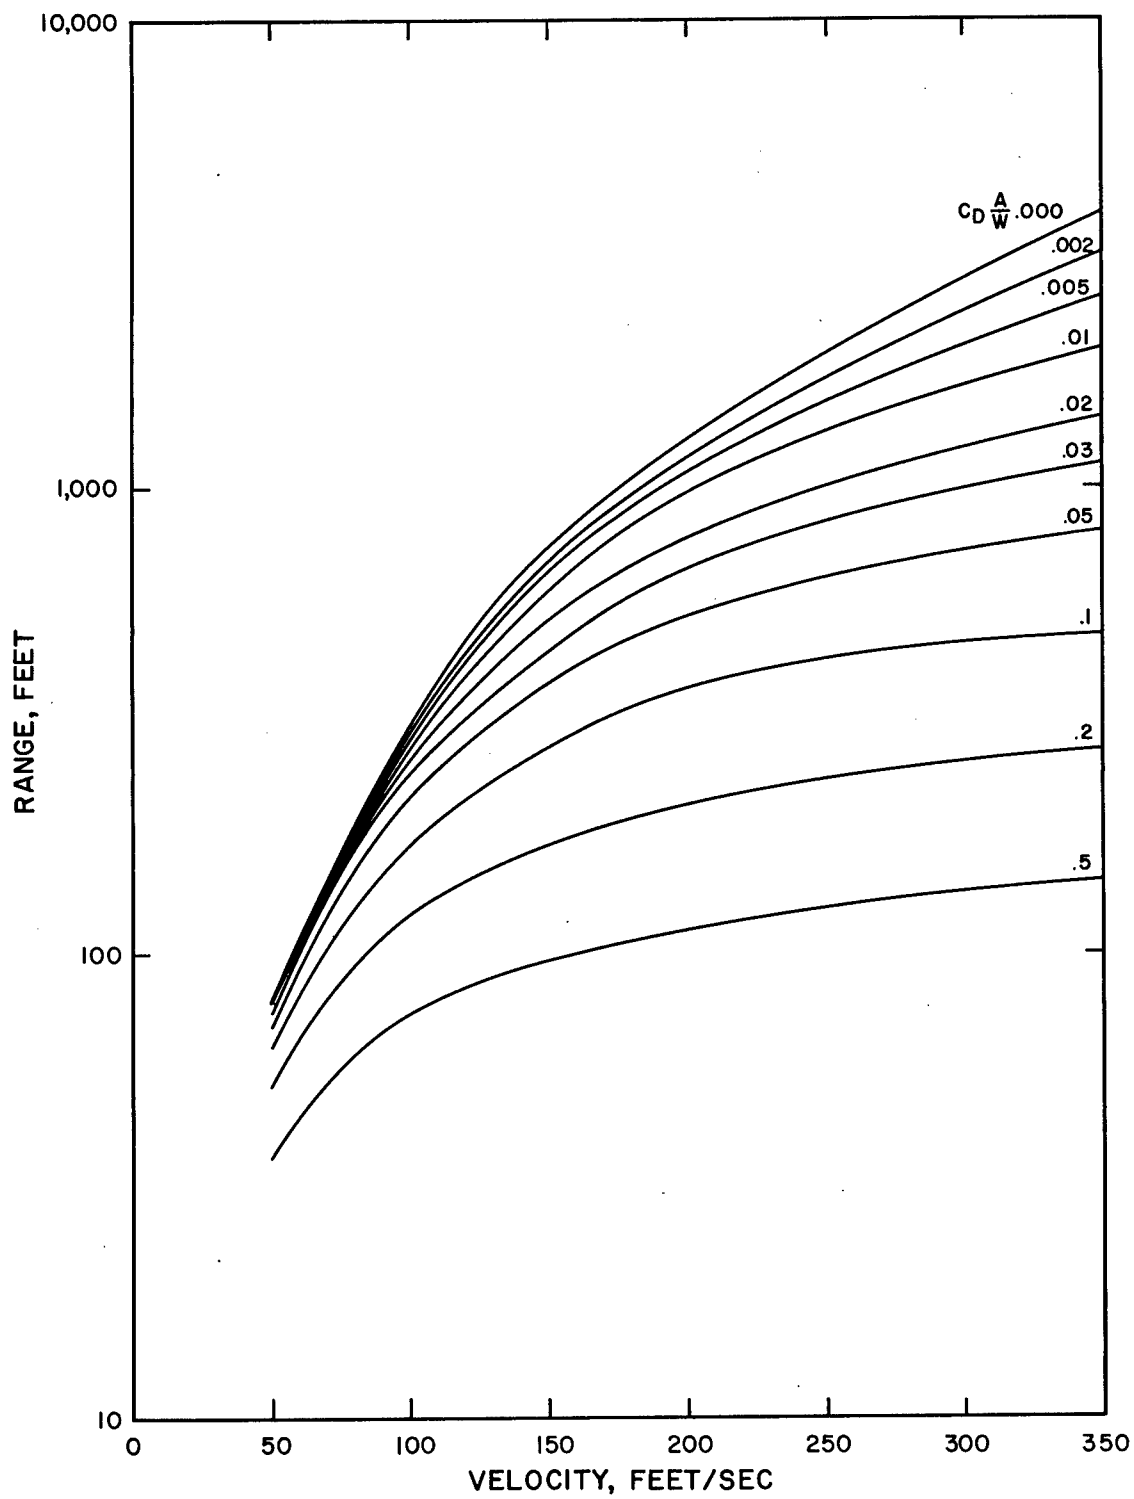
FIGURE 12. RELATION BETWEEN INITIAL VELOCITY AND GROUND RANGE
(LOW VELOCITY RANGE)

Figures 12 and 13 indicate the relation between initial velocity and distance traveled for fragments of different drag coefficients, cross sectional areas, and weights using an assumed flight angle of 45°. Table IV gives the identities and pertinent data for selected fragments from the S-IV All Systems Vehicle explosion and initial velocities estimated from FIG 12 and 13.

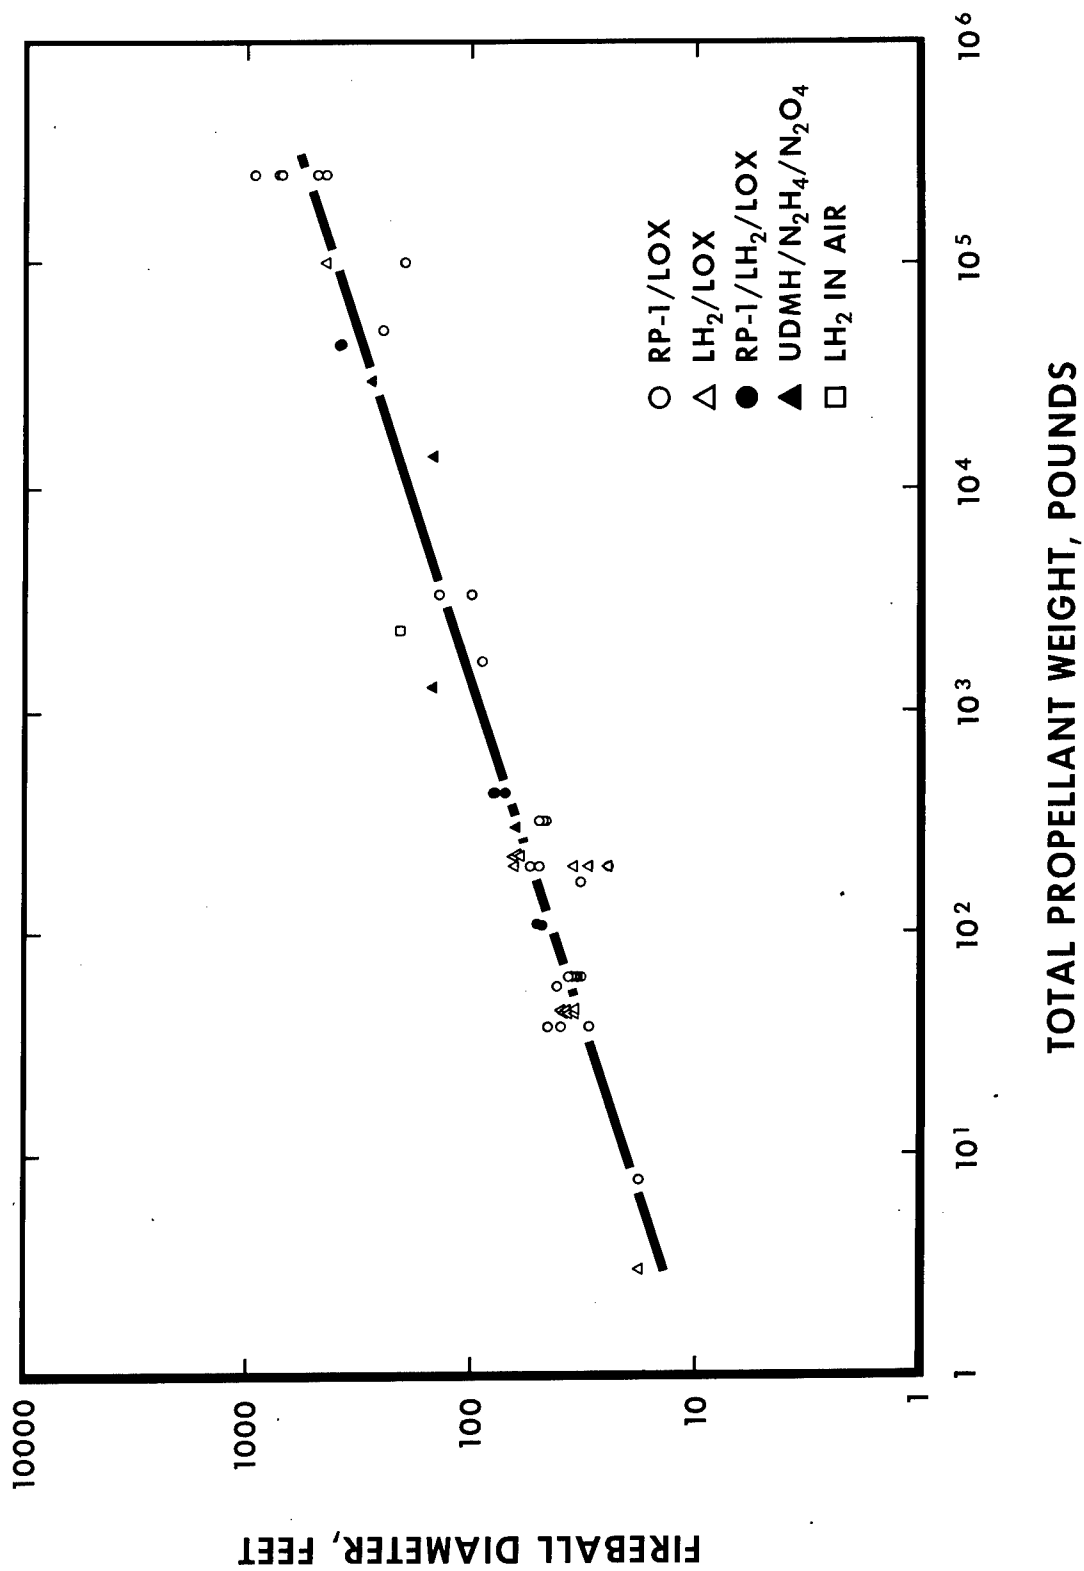
FIGURE 15. FIREBALL DIAMETERS FOR VARIOUS WEIGHTS AND TYPES OF PROPELLANTS

Figure 15 shows the maximum diameter attained by the fireball with similar values derived from small scale experimental tests and full scale vehicle failures involving LOX/RP-1 and LOX/LH₂ and N₂O₄/Aerozine 50. The data are logarithmically related in accordance with the equation:

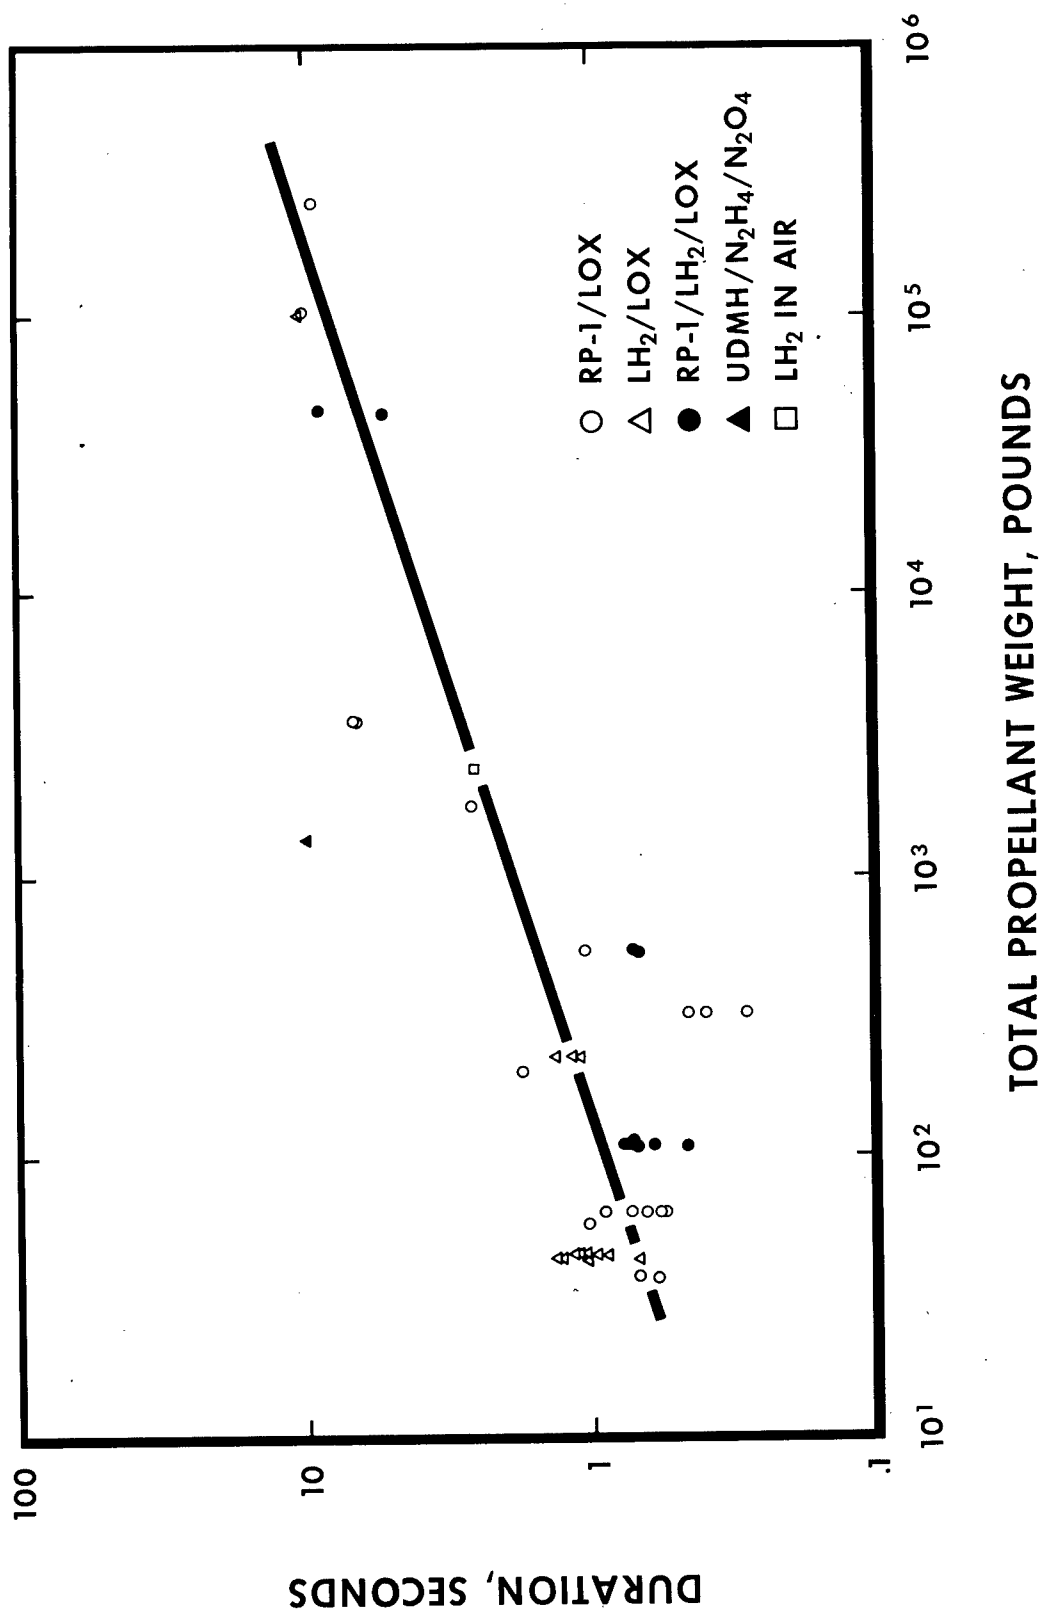
FIGURE 16. FIREBALL DURATION FOR VARIOUS WEIGHTS AND TYPES OF PROPELLANTS

Figure 16 shows the duration of the fireball together with similar values for small scale experimental studies and full scale vehicle failures. These data scatter widely and, therefore, are compatible with equations having a wide range of slopes. For consistency with the results obtained from the other explosive parameters, a slope of 0.33 is used; this appears to adequately describe the data. No doubt, much of the observed scatter is due to the difficulty in judging when the fireball has subsided.
